# **SAFETY BULLETIN**

## **LADDER INSPECTIONS**

# Significant Near Miss Involving a Fiberglass Extension Ladder

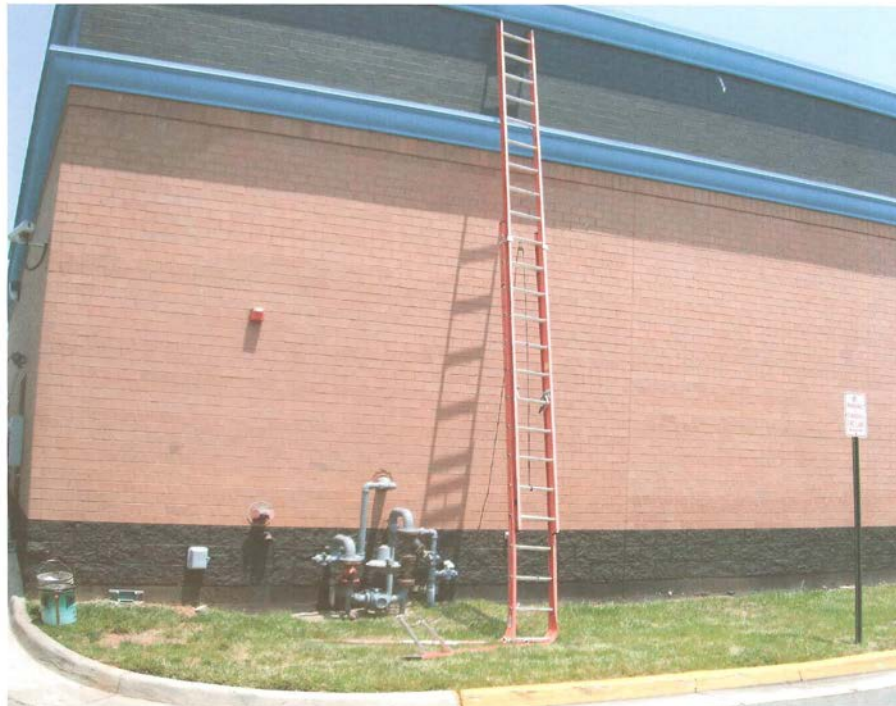
As the technician was climbing the ladder he felt the ladder start to give from underneath him. He was able to reach and hold on to the roof edge as the ladder collapsed. The second technician was able to get another ladder from their service truck, set the ladder up and get the first technician down safely without incident.

Ladder collapsed – worker was able to grab on to the leading edge of the building

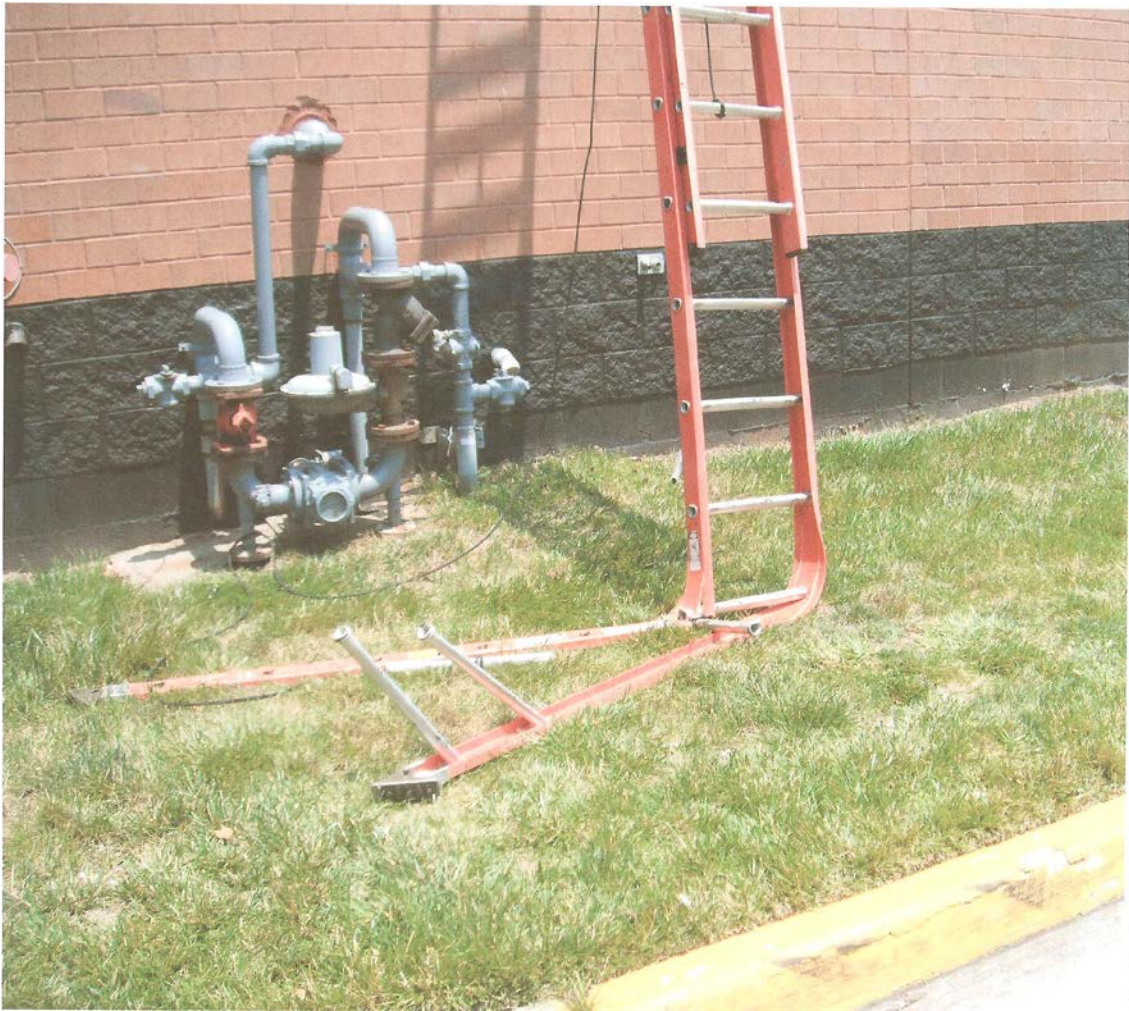
The lower section of the ladder failed

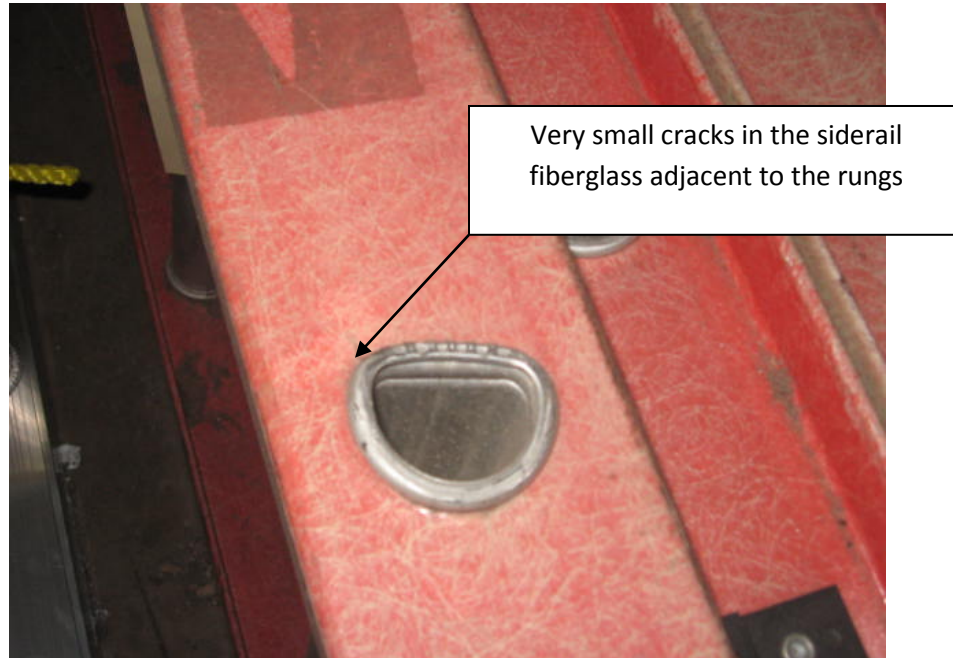
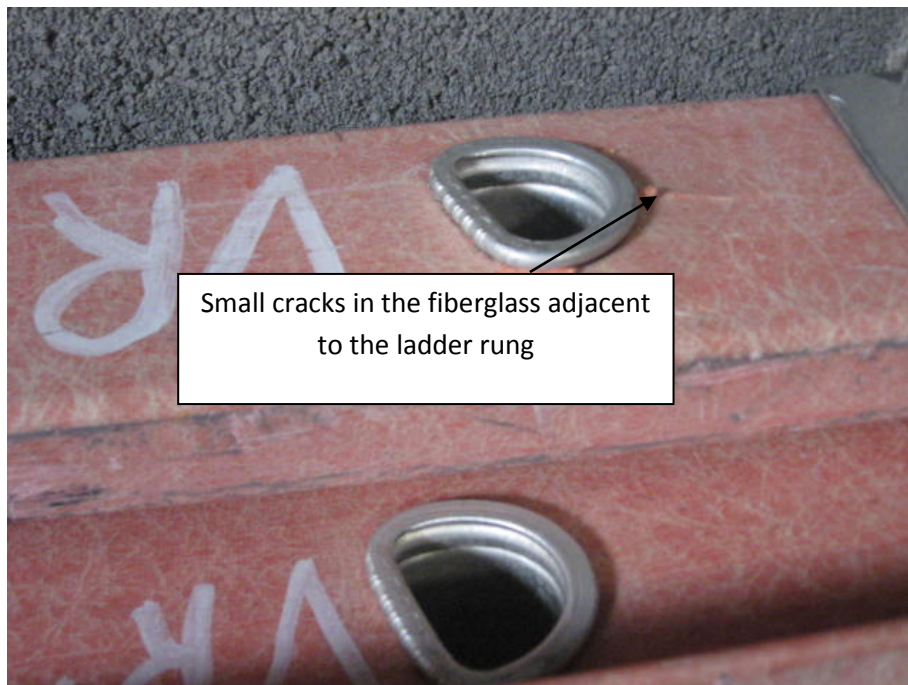
All fiberglass ladders were immediately brought in from the field and closely examined for any possible defects or damage. The company found that on approximately 20% of their fiberglass extension ladders there were very small cracks in the fiberglass on the siderails immediately next to the rungs of some ladders.

The small cracks found in the siderails of the extension ladders were not noted to be in any pattern along the siderail. The cracks and splits in the fiberglass were found to be immediately next to the rungs on the outside portion of the siderail.

Currently it is believed the fiberglass may have been damaged or fatigued during the manufacturing process when the rungs were crimped into the siderail of the ladder.

The small cracks around the rungs are not easily detected by a quick visual inspection. Workers need to 'feel' with their finger tips for any raised spots in the fiberglass and remove any debris along the side rails in the areas where the rungs are crimped to check for small cracks or splits. The cracks were not found in any pattern or specific location on all the ladders inspected. It is important to inspect each rung on both the exterior and interior side of the siderail for any signs of cracks or splits in the fiberglass.

Any fiberglass ladder with these small cracks should be removed from service.

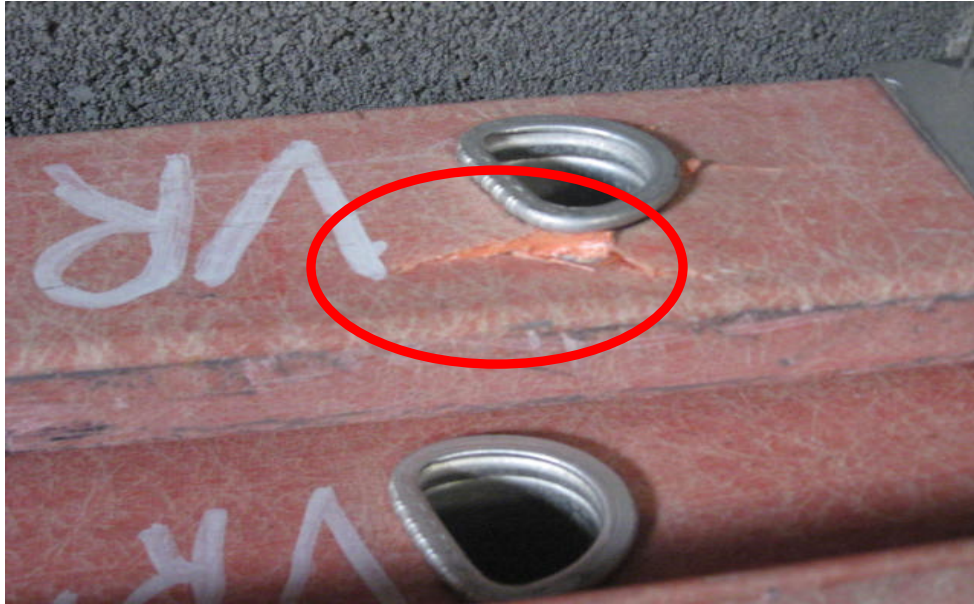
In addition to the small cracks in the fiberglass in some areas the fiberglass material had split.
